ST. AUGUSTINE THE BRIDGE OF LIONS

SECTION 1: DATA GATHERING & SITE ANALYSIS OF PARK APPROACHES

REPORT JANUARY 2001

PREPARED FOR THE DISTRICT 2 FLORIDA DEPARTMENT OF TRANSPORTATION

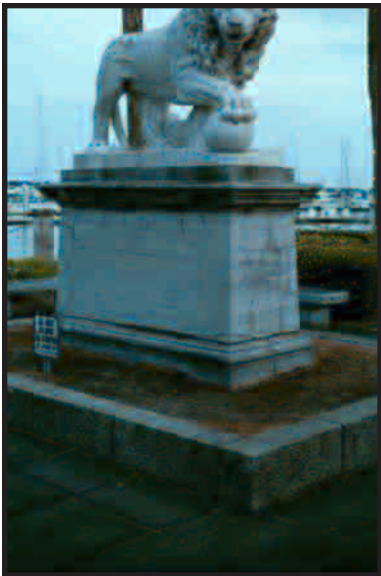
The West Park Approach's most historically significant features are the original lion statues, now over 75 years in age. Although, consideration was given to repair the condition of the lions during their re-location in the mid-1980's, there is now evidence from current research that suggests the lions were not provided any conservation treatment during relocation. Only the lions' pedestals and bases were replaced to provide better structural integrity against the negative effects of soil erosion and settling. Because of the lions' historical value, developing a method for their proper conservation treatment will be given priority during the site's design development phase.

Weathered lion and base

Sculpture experts who are knowledgeable of the conservation treatment necessary to preserve the lion statuary's marble composition, have recommended that preventative treatments be completed on the lions annually to slow the marble's natural weathering process. Based on current research, there is evidence that little or no conservation treatment has been given to the lion statues. Educational opportunities exist for visitors and local residents, if the conservation treatment process is conducted transparently at the lions' temporary storage location, as part of a larger public exhibit about the rehabilitation effort.

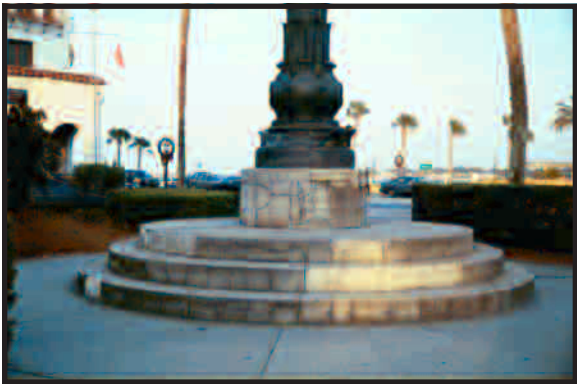
Cracked concrete base of flagpole

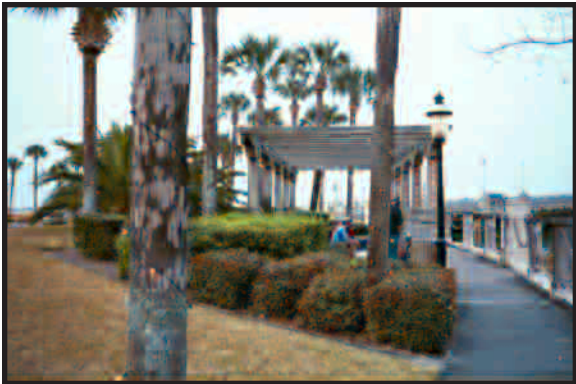
The two pergolas, which were installed in the mid-1980's, are in good condition. Because the pergolas were surrounded by planted berms at the time of their installation, they offer some protection from traffic noise and visual exposure to the street. The pergolas are not part of the original design, however, and their historic appropriateness should also be taken into account in the overall rehabilitation effort.

South pergola at west park approach

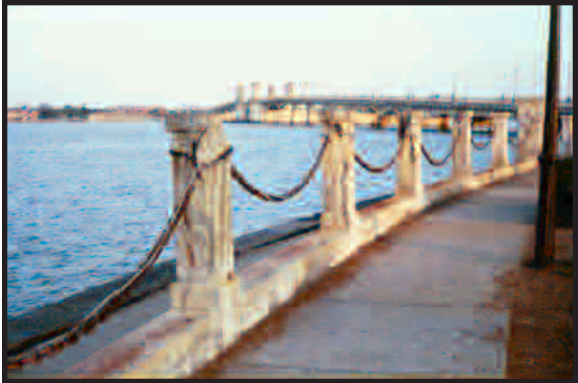
Cracked and rusted railing system

All other original site elements of the west and east park approaches should be assessed for their salvage and/or replacement value. These elements include the original concrete post and chain railing detail that still stand along the bulkhead as well as thriving plant material such as the sabal palm, date palm, and India Hawthorn. Only a few of the original lanterns are still hanging for study at the Lightner Museum and the St. Augustine Historical Society Research Library. The remainder of the lanterns had been scrapped after their replacement in the 1970's, because their steel construction had been too badly rusted to salvage.

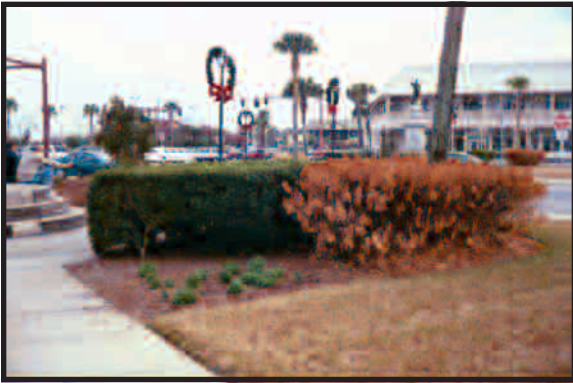
Plants that have shown obvious signs of freeze damage are the hibiscus and lantana. Fortunately, these plants have only been used as accents in the West Park Approach and have not been integrated as large masses into the landscape design.

Freeze damage of Hibiscus at Anderson Circle

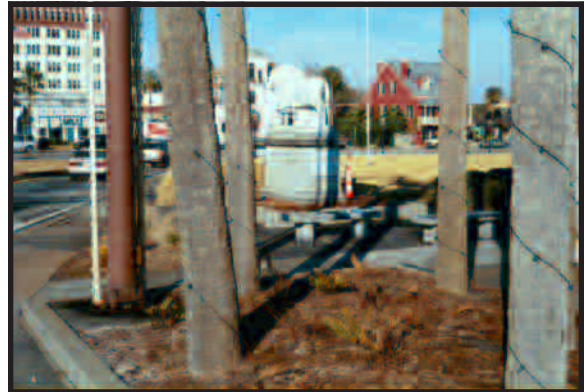
The majority of plant materials chosen for the West Park Approach appear to be in good condition in spite of their exposure to harsh environmental conditions. The sabal palm, yaupon holly, and India hawthorn are excellent choices because of their native tolerance of the conditions. The native coontie fern, though typically quite resilient, appears to be suffering at the northeast end of the park, probably due to its extreme exposure to full sun, automobile exhaust, wind, and especially salt intrusion. If re-located to a slightly more protected area, the coontie fern will probably flourish.

Declining Coontie Fern
