April 11, 2011

Hound Ears Club Roadway Evaluation Study Executive Summary

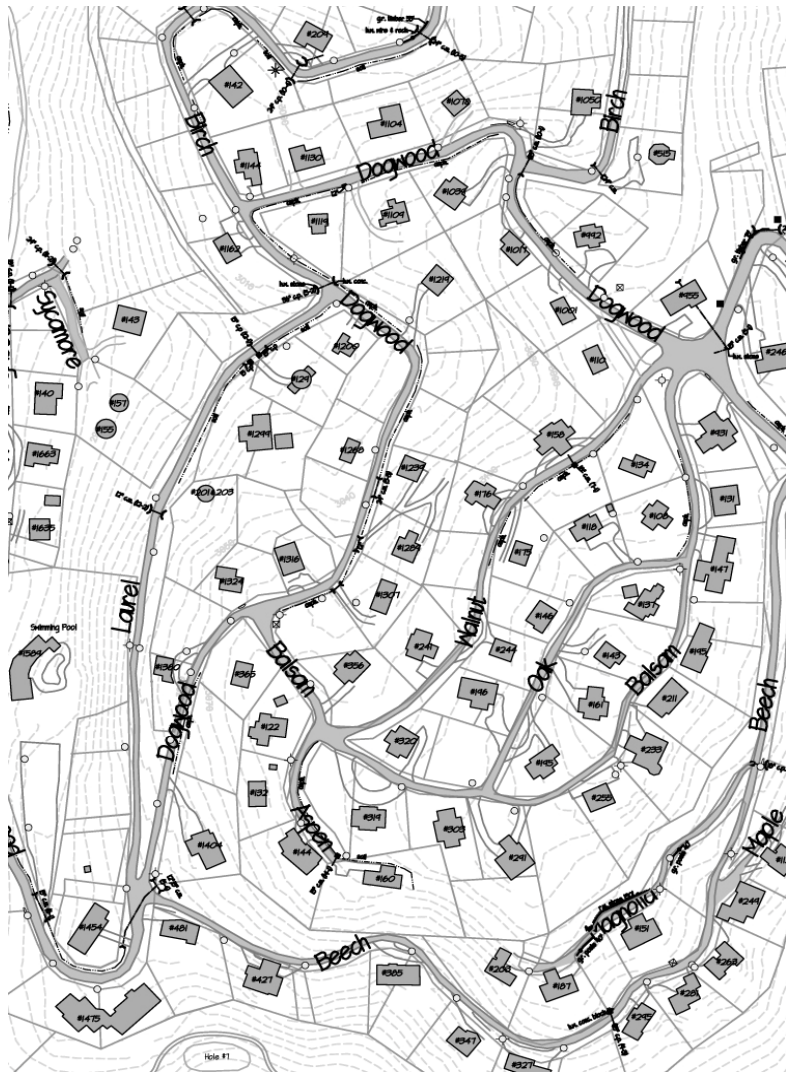
Road Segment: 6 Dogwood: pool to Sycamore

3.4

B

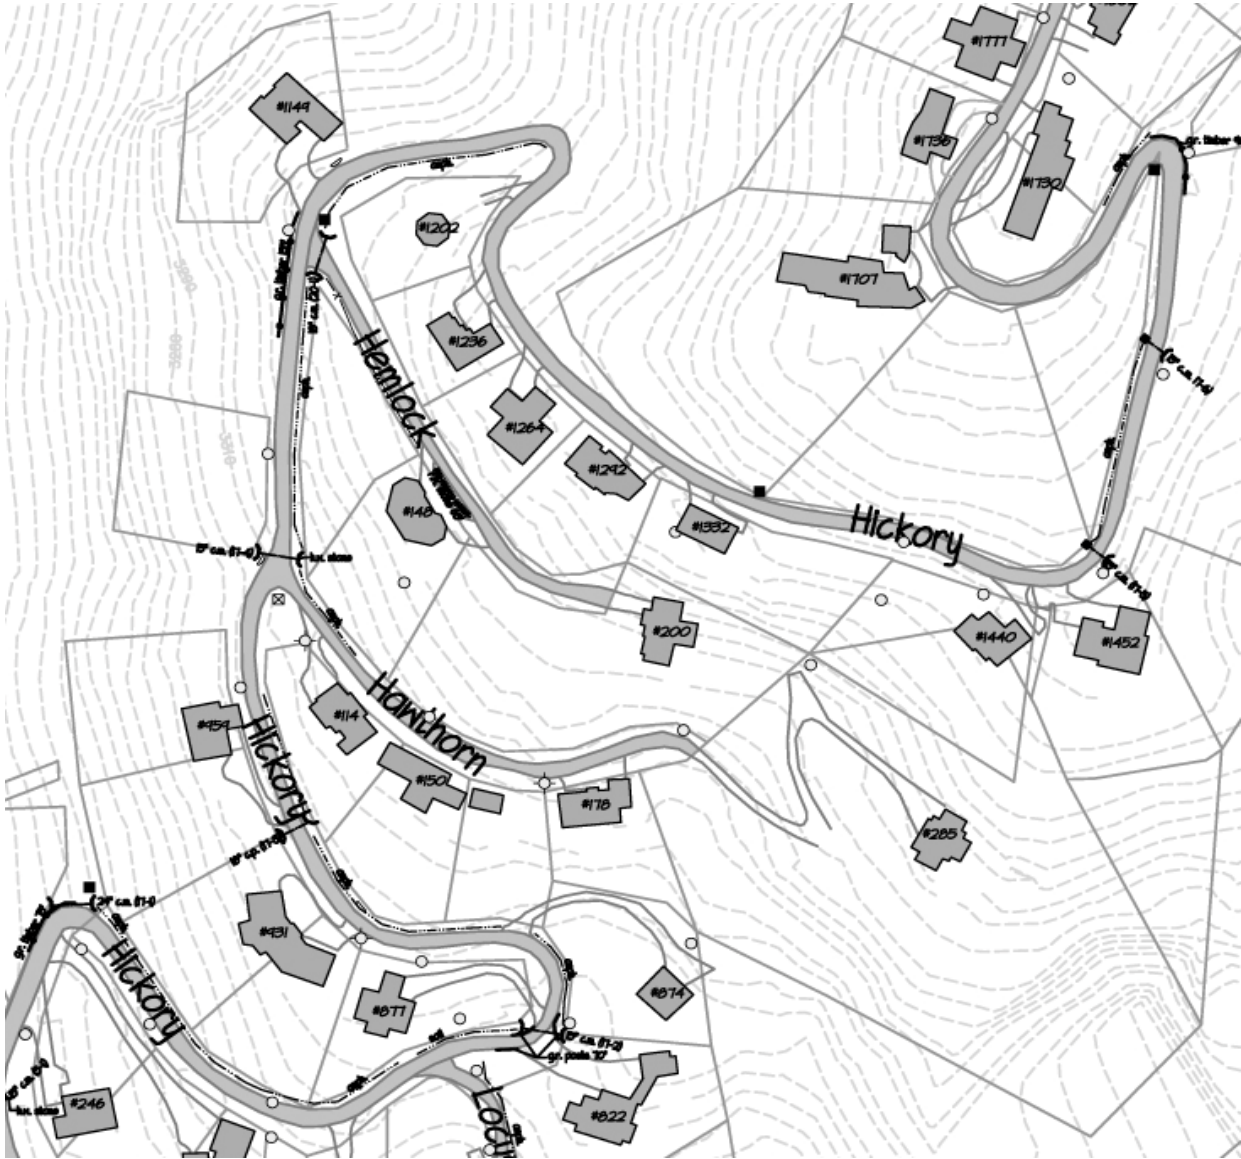
Road Segment: 20 Hemlock

1. Drainage ssue at #148

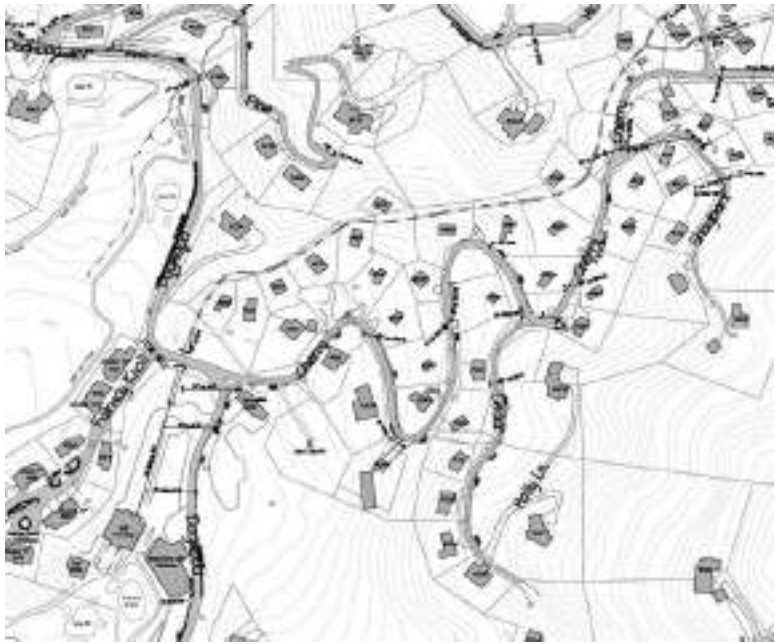
Road Segment: 25A Cherry: Dogwood to Hickory

- Guardrail at Cedar in disrepair - Critical
- Paving, drainage (25A-1-8) & striping replaced in 2009

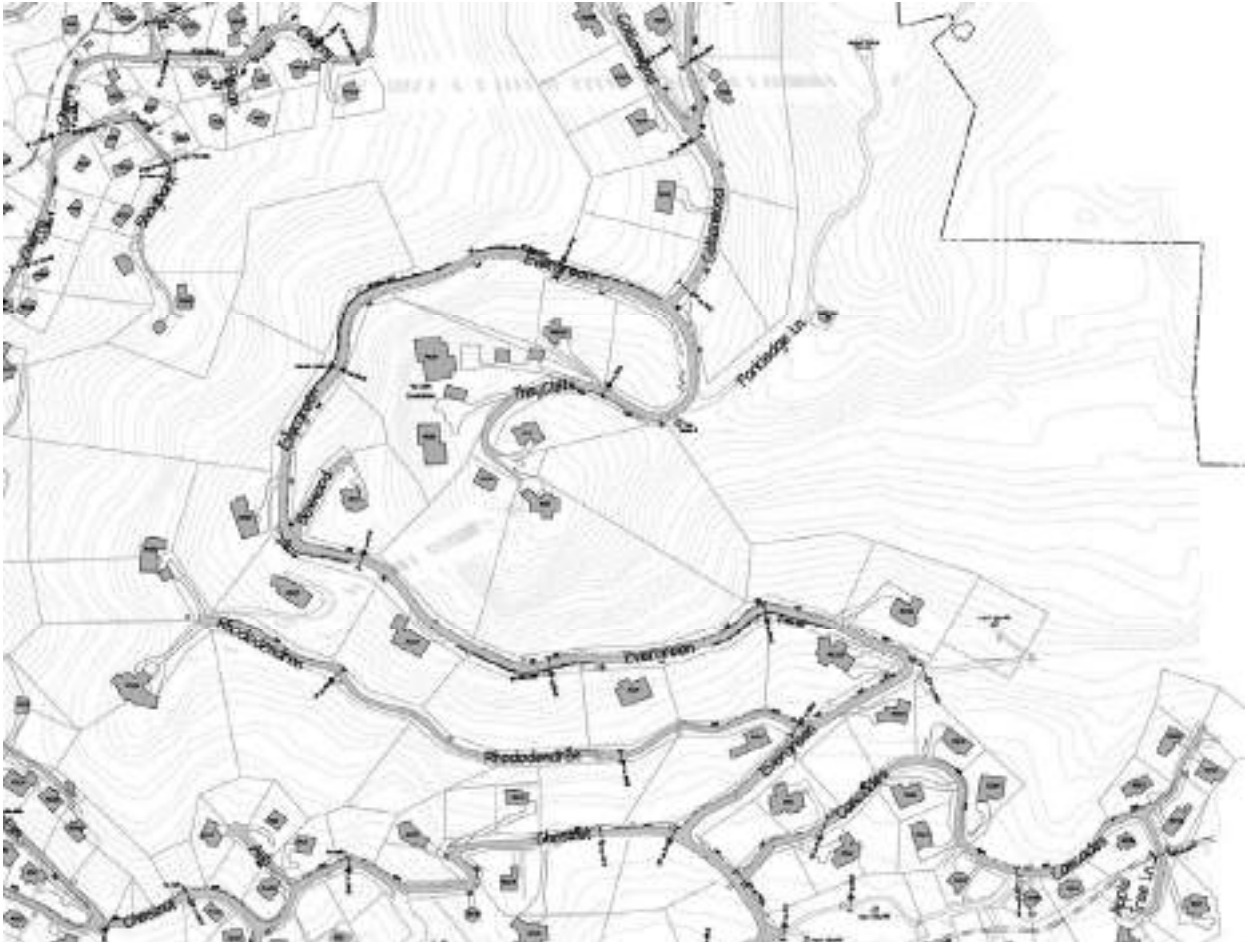
Road Segment: 44 Evergreen: Chestnut to the Cliffs

1. Guardrails & striping deteriorated - Critical
2. Settlement, cracking and drainage issues - Critical
