Framework Plan

Cathedral Basilica | St. Augustine, FL
ML+H Project No. 17.22.0 | 08.07.17

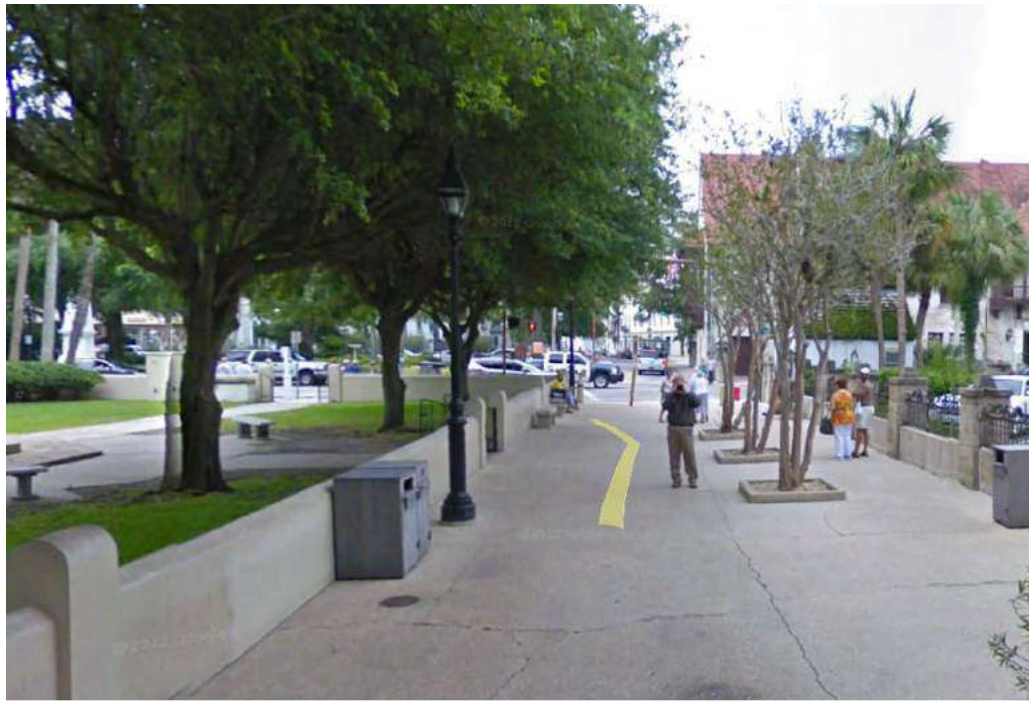
Oaks along one side of St. George Street

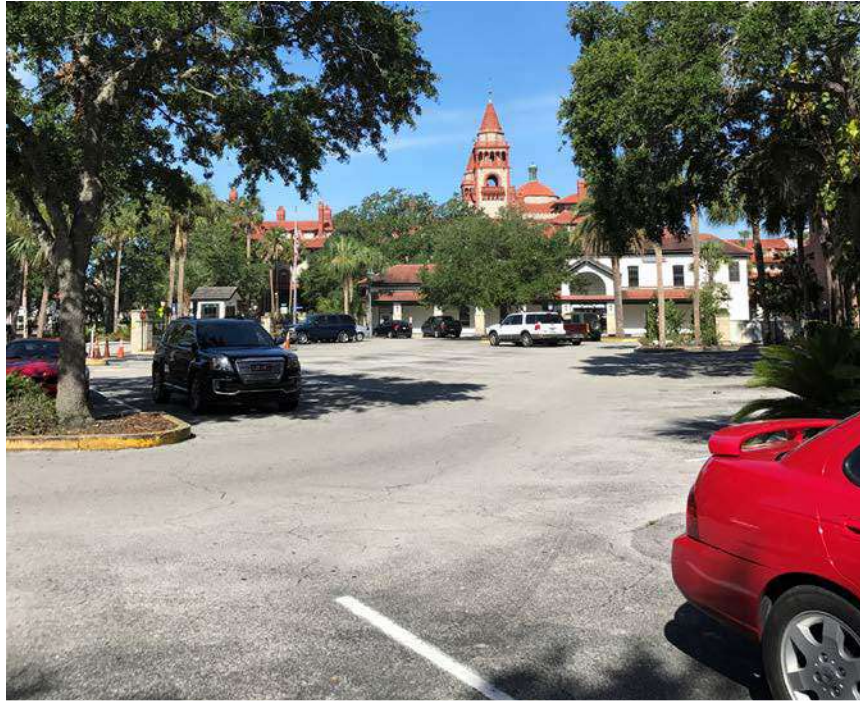
Existing "BoA" parking lot

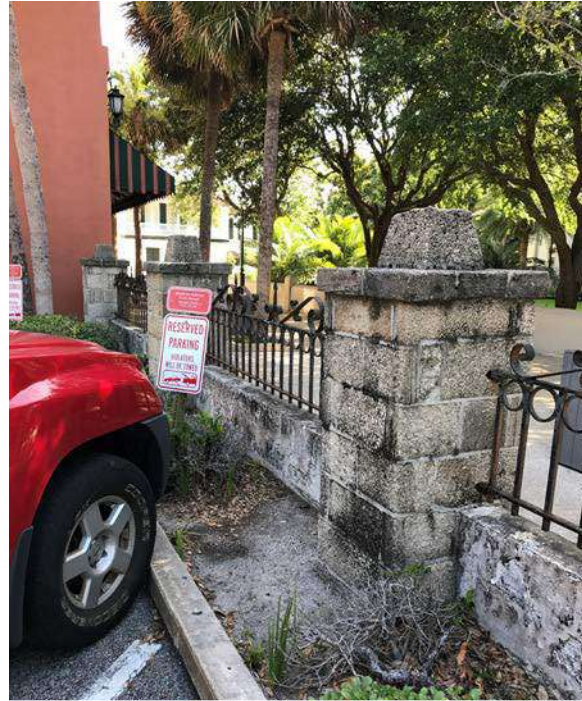
Cast iron and coquina

Parking attendant and cones directing traffic

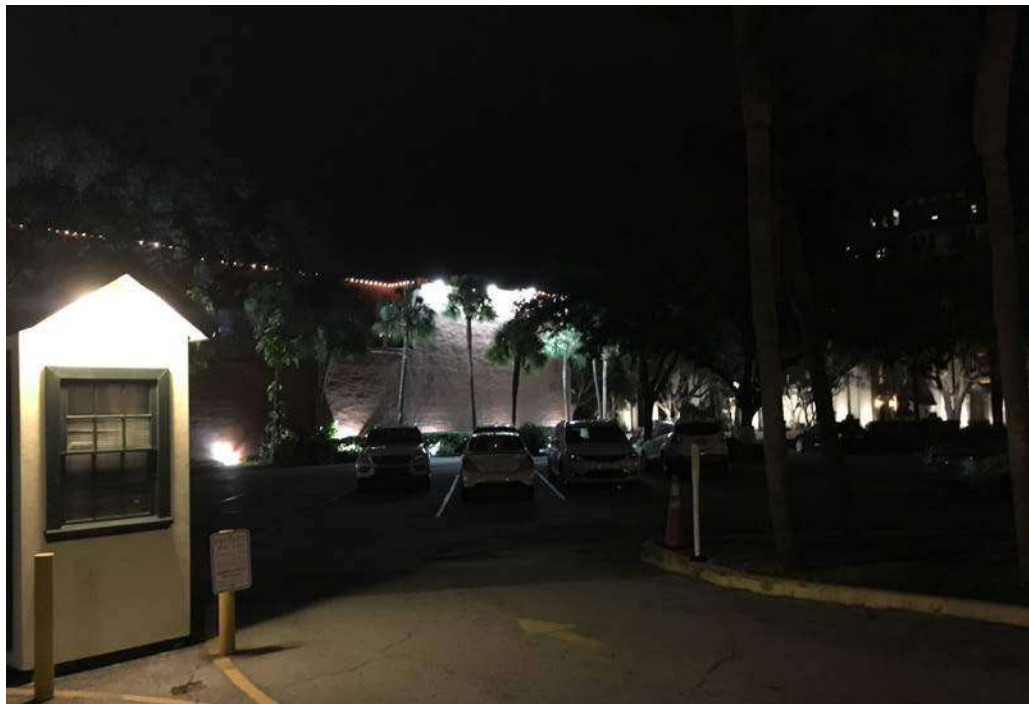
Poorly lit parking lot

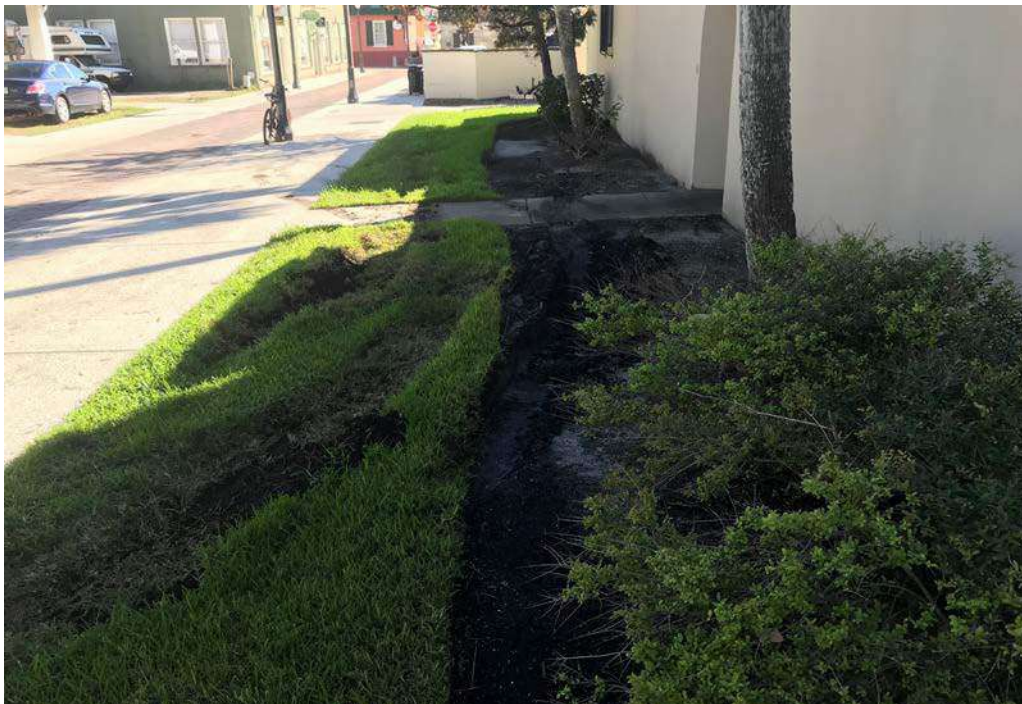
Treasury Street traffic affecting landscape

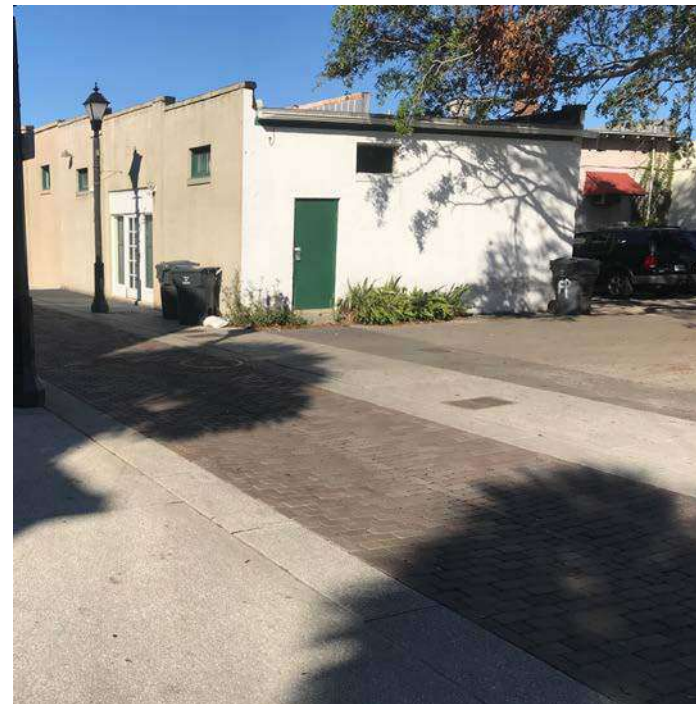
Lack of buffer space

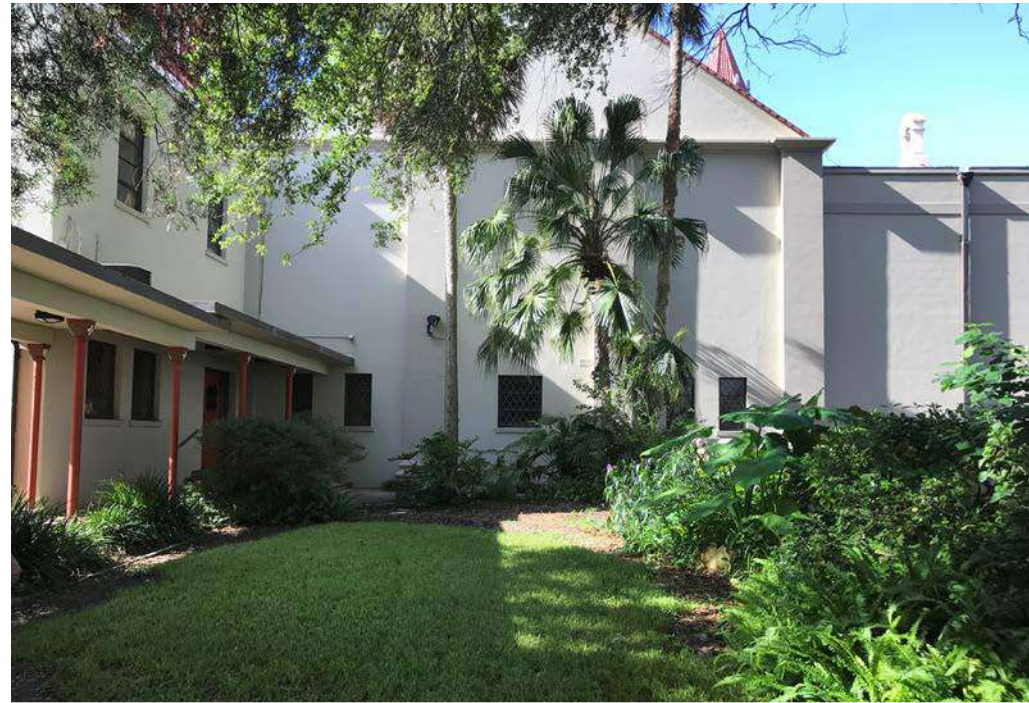
Vegetation taking over gathering space

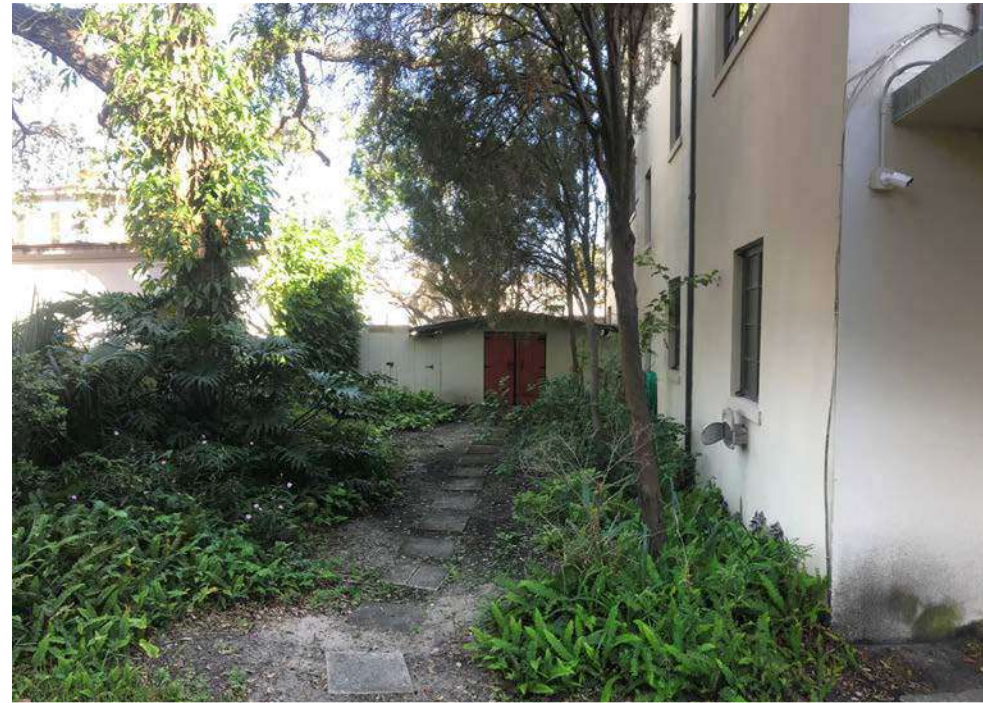
Vegetation and shed detract from space

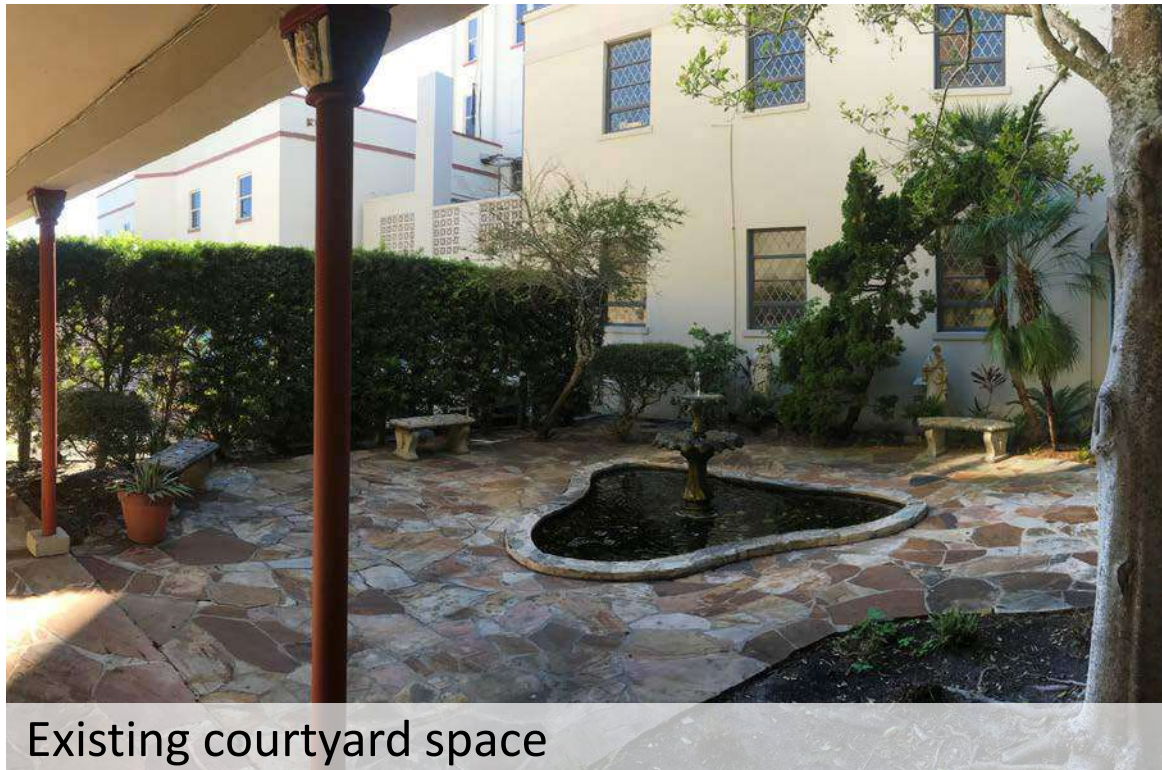
Existing courtyard space

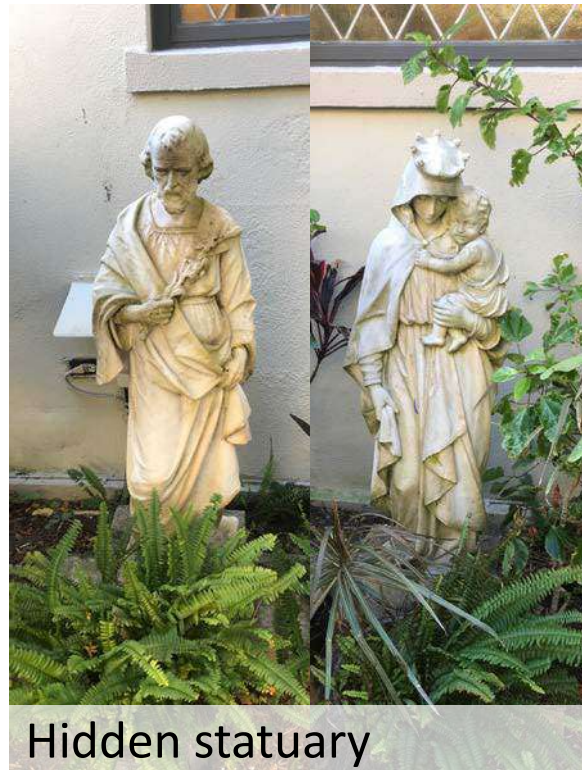
Hidden statuary

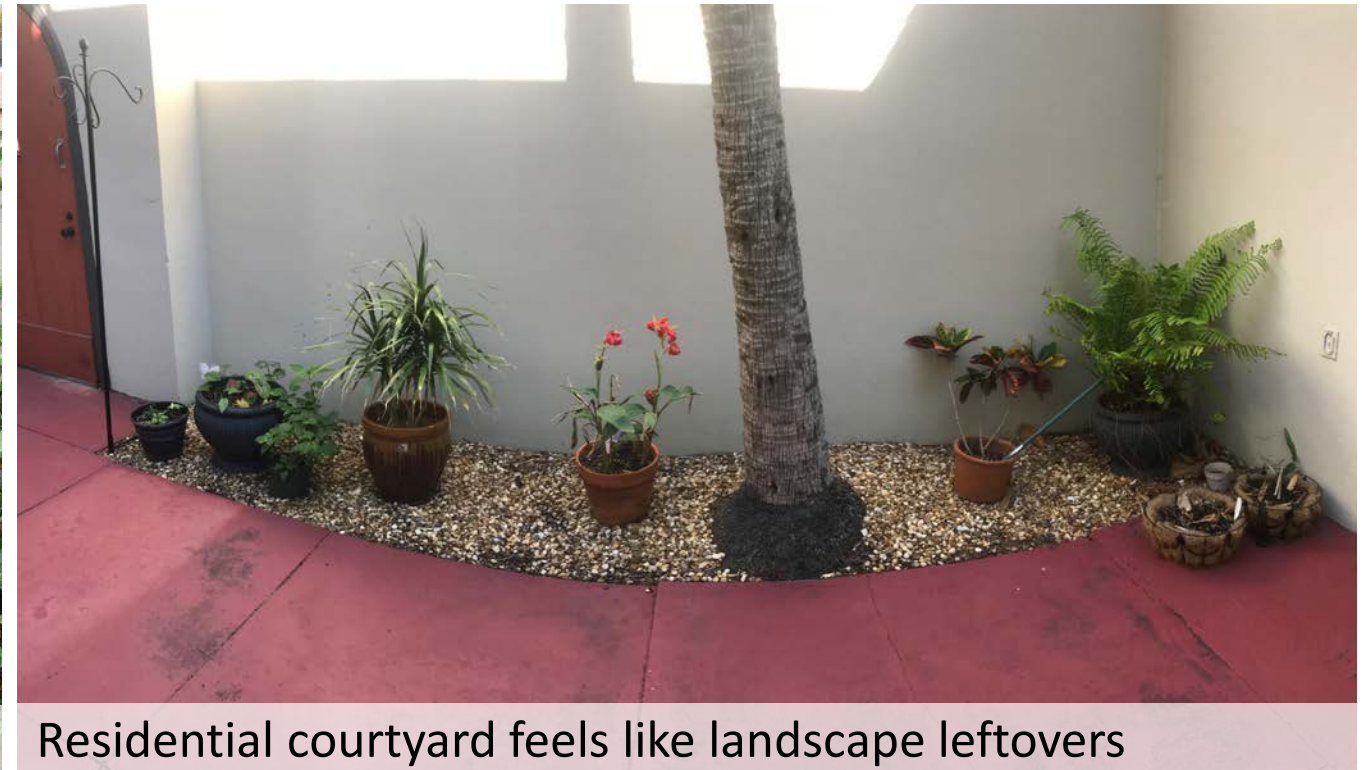
Residential courtyard feels like landscape leftovers
