ST. AUGUSTINE THE BRIDGE OF LIONS

SECTION 1: DATA GATHERING & SITE ANALYSIS OF PARK APPROACHES

REPORT JANUARY 2001

PREPARED FOR THE DISTRICT 2 FLORIDA DEPARTMENT OF TRANSPORTATION

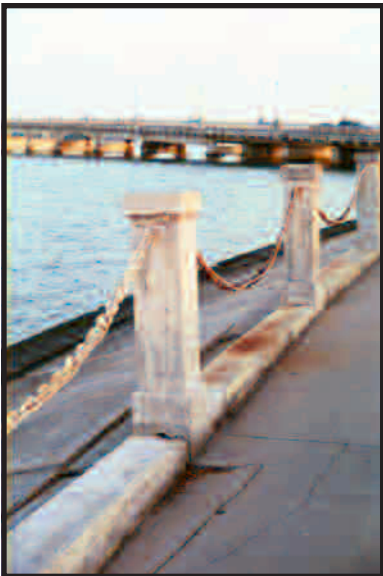
Aging post and chain railing system along bulkhead

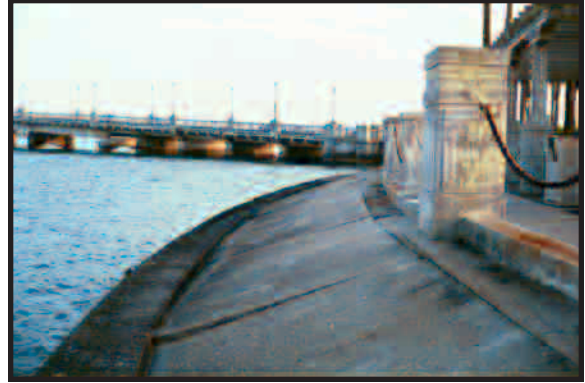
South portion of west park bulkhead

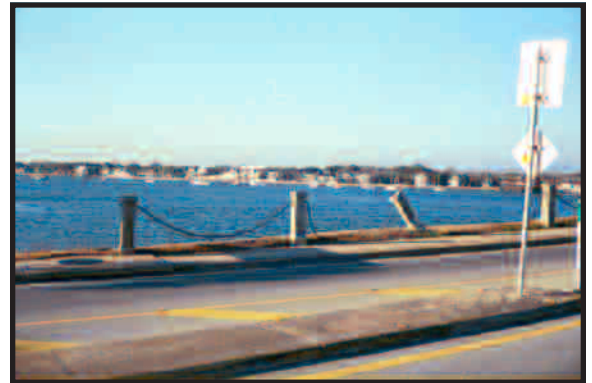
The original pre-cast concrete post and chain detailing is still located on either side of the bridge's approach, though in extremely poor condition. No other site features, besides the post and chain system, were developed in the original design of the east approach.

Aging concrete post and chain railing system

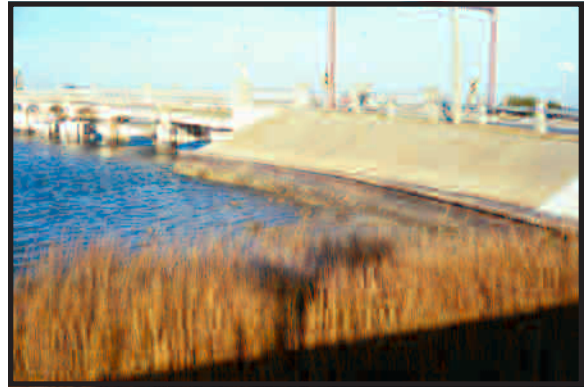
South portion of bulkhead at east park approach
