ST. AUGUSTINE THE BRIDGE OF LIONS

SECTION 1: DATA GATHERING & SITE ANALYSIS OF PARK APPROACHES

REPORT JANUARY 2001

PREPARED FOR THE DISTRICT 2 FLORIDA DEPARTMENT OF TRANSPORTATION

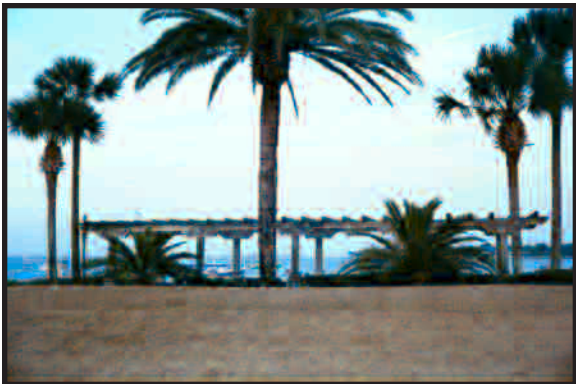
North pergola at west park approach

The two pergolas, which were installed in the mid-1980's, are in good condition. Because the pergolas were surrounded by planted berms at the time of their installation, they offer some protection from traffic noise and visual exposure to the street. The pergolas are not part of the original design, however, and their historic appropriateness should also be taken into account in the overall rehabilitation effort.

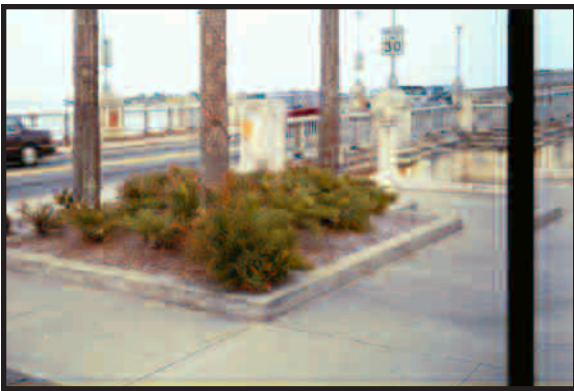
North portion of west park bulkhead

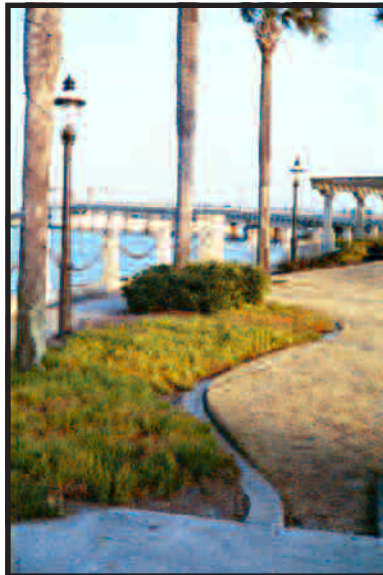
Aging bulkhead

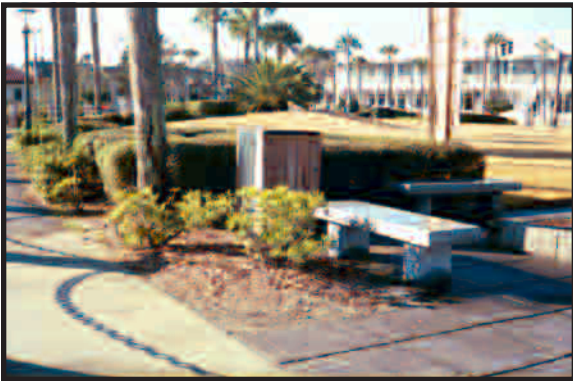
The pittosporum and elaeagnus, however, appear to be in fair to poor condition because they are maintained at a height well below their potential height and spread. Currently, their height is maintained between 3 and 4 feet, even though they can reach well over 15' in height at maturity. It is recommended that these plants eventually be substituted with plants that are naturally more compact in size and more easily maintained.

Pittosporum at s. upper plaza

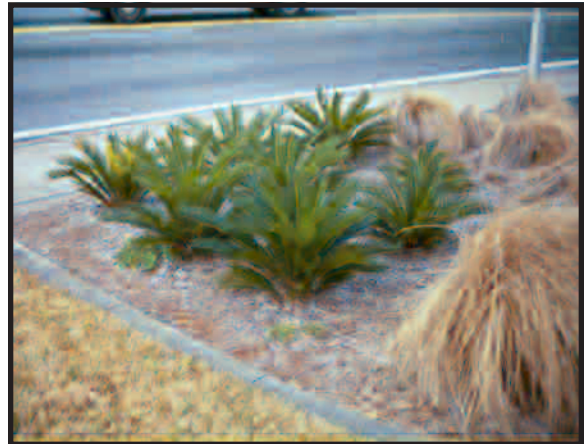
Thriving Coontie Fern
